Manhole Inspection Summary

Manhole # S21WW1122MH

Location Address: **14 ROLAND GREEN** Cross Street: **CROSS KEYS RD**

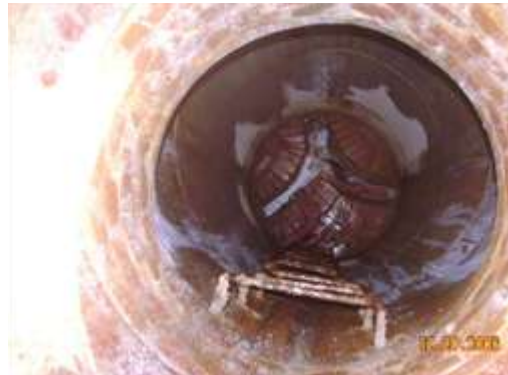
Top View

Bench and Channel debris.

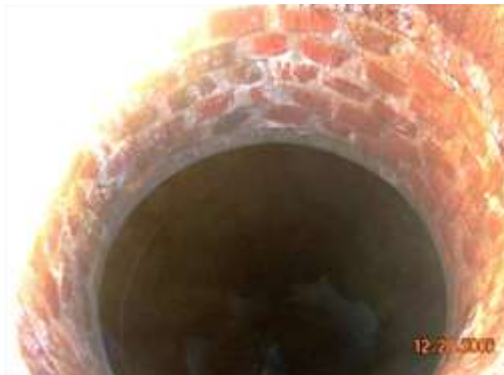
Defect

Frame leaks. Adjustment, Corbel and Barrel infiltration.

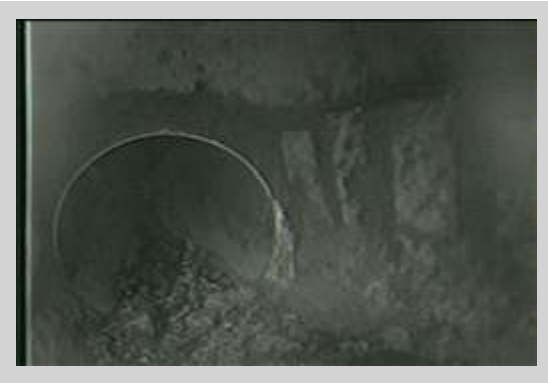
Pipe Out @ 12 O'Clock

Deposits: ☐ None ☒ **Mud** ☐ Sludge ☒ **Debris** ☐ Grease

Silt Depth: **0.5** (in.)

Deposits Extent: **Light**

Infiltration: **Evidence**

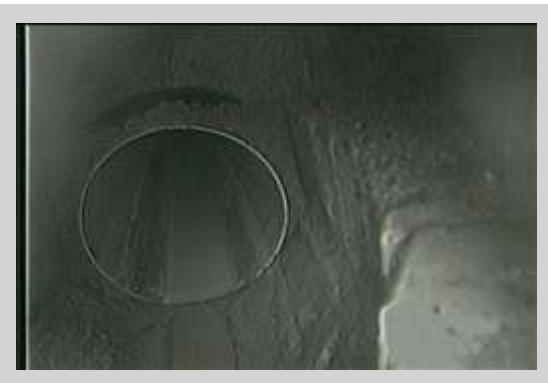
Pipe In @ 4 O'Clock

Infiltration: **Evidence**

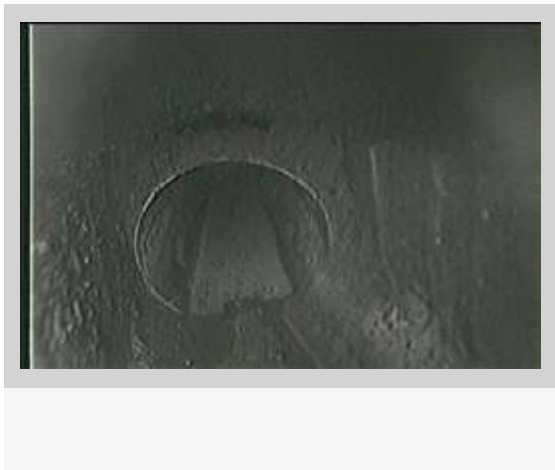
8 in. Circular Gravity Sewer
Pipe In @ 8 O'Clock

Infiltration: **Evidence** Pipe Seal Cond: **Unknown**
